## **INSPECTION REPORT**

Permit Number: B2013-9606

Address: 200 Hope St

RE: Stop Work Order - 200 Hope St - Unsafe Conditions - structural columns basement area

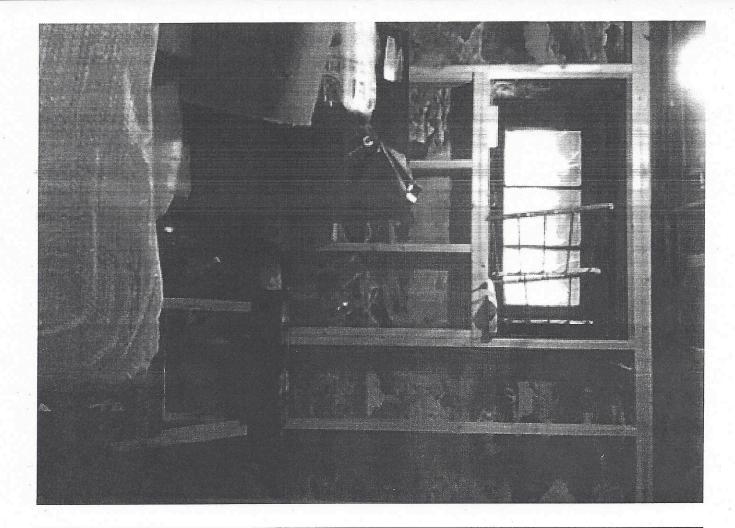
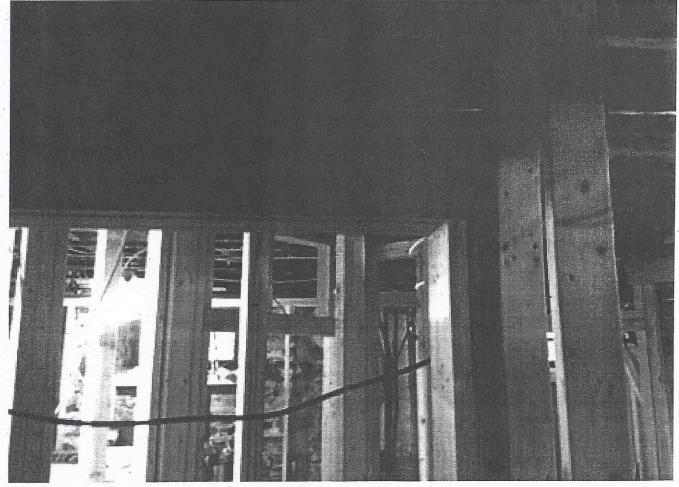
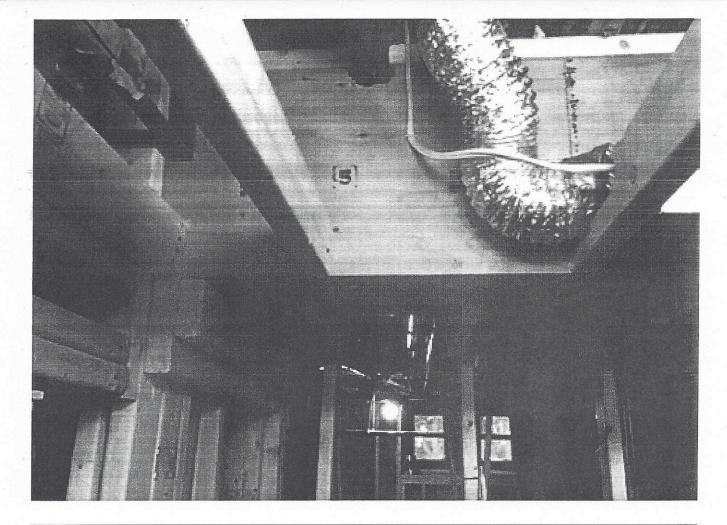
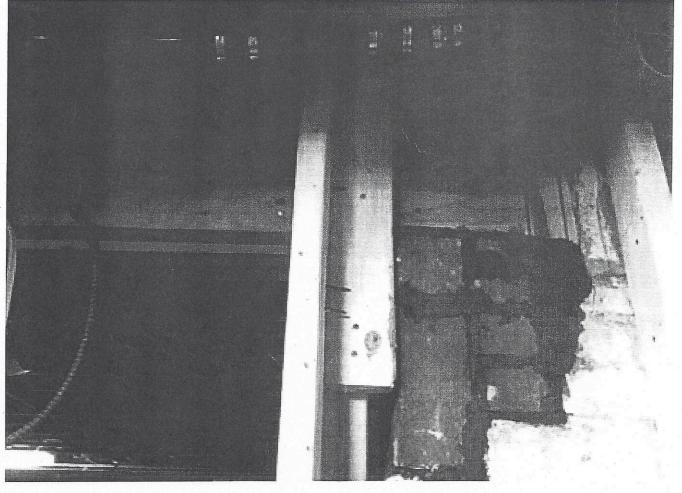
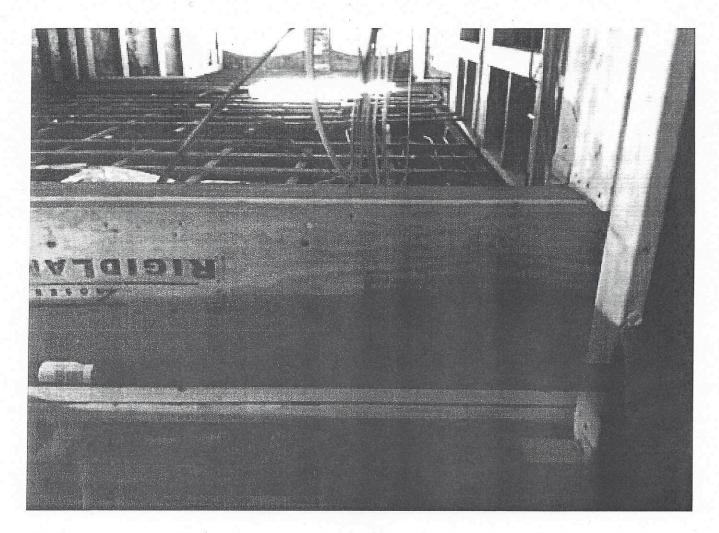
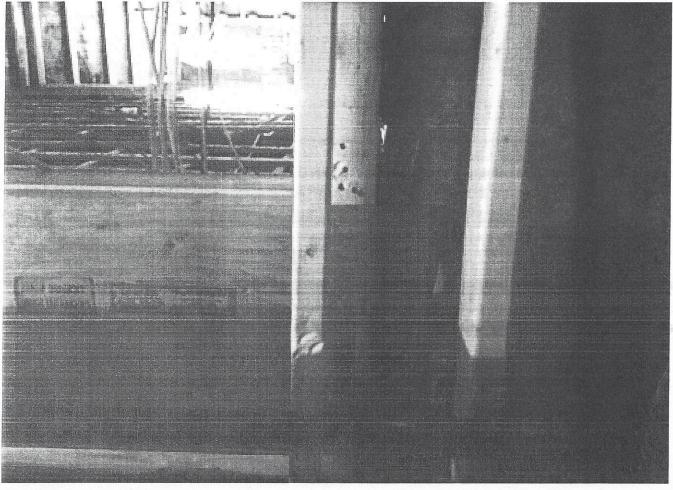
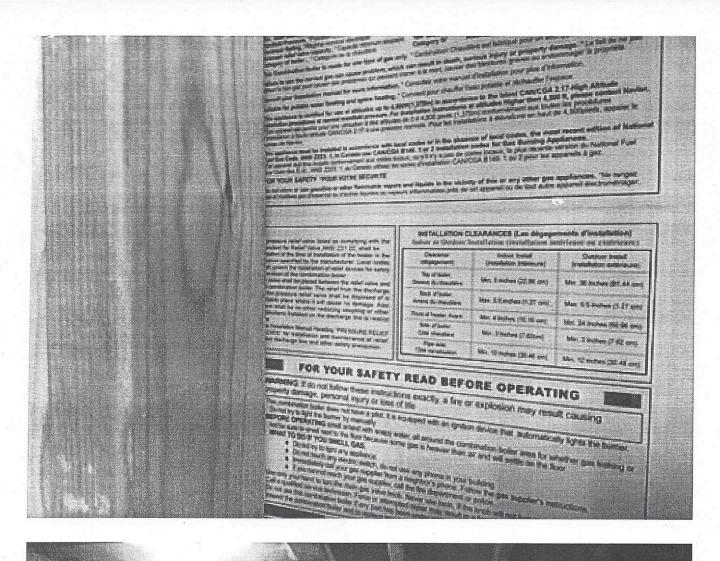
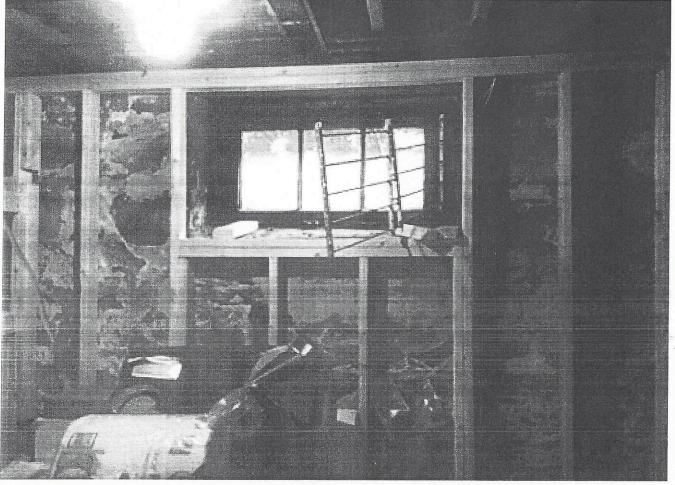
Columns added to beams.

Gang beams need to be through bolted.

Need details on egress windows, not built to approved

Proper clearance not provided at boilers.

"Engineering back up must be provided for all substitutions for structural element on the approved plans...Contractor must provide structural back up for all columns and beams that vary from the approved plans. Provide drawing of footing for new load bearing wall..

Provide Structural engineer's report for: all wood beams demonstrating capacity to support all floors above, for all wood columns demonstrating capacity and slenderness ratio to support beam load, for footing size and location for all columns and load bearing walls, and for notched beam in bathroom.
